Appendix C

Photograph Plates

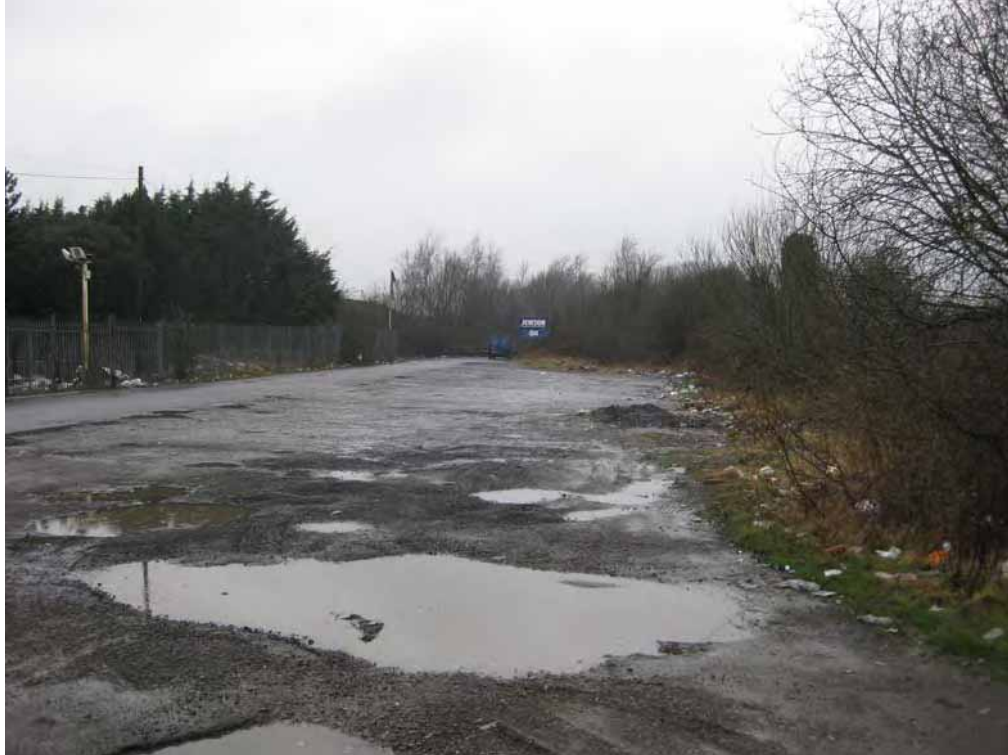
Plate 1 - Looking northeast, access is made directly from the B4181 Coity Road sign posted Jewson Builders Merchants.

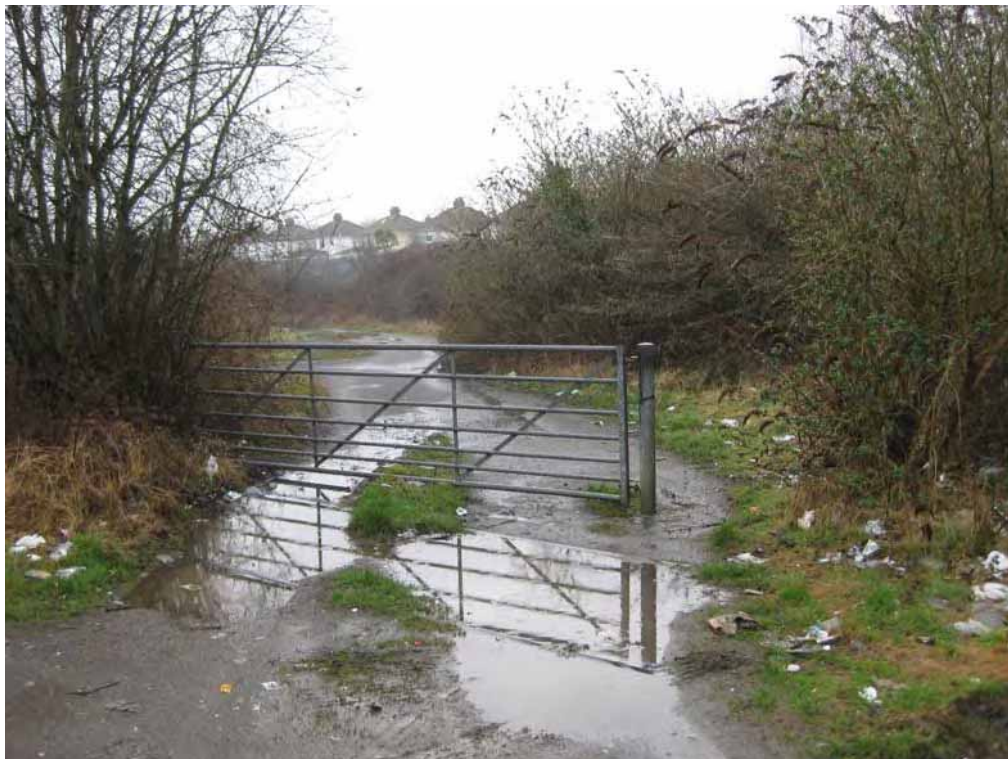
Plate 2 - Looking northeast towards eastern side of the road onto the site is a gate allowing car access towards the south eastern area of the site.

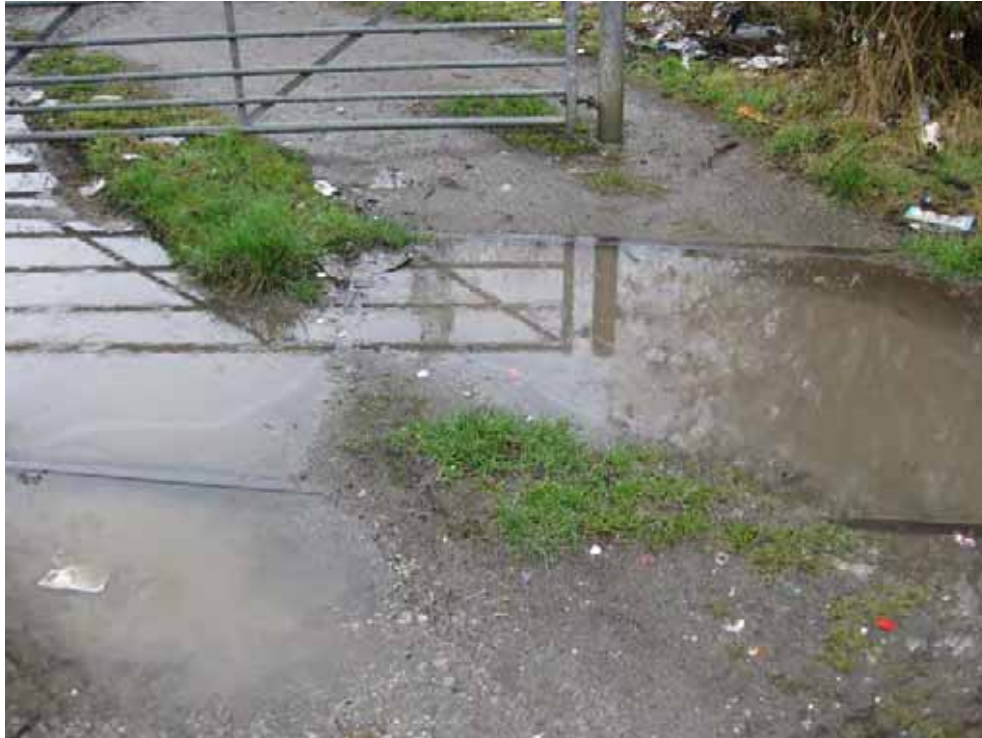
Plate 3 - Facing northeast, directly in front of the gate is evidence of the former railway.

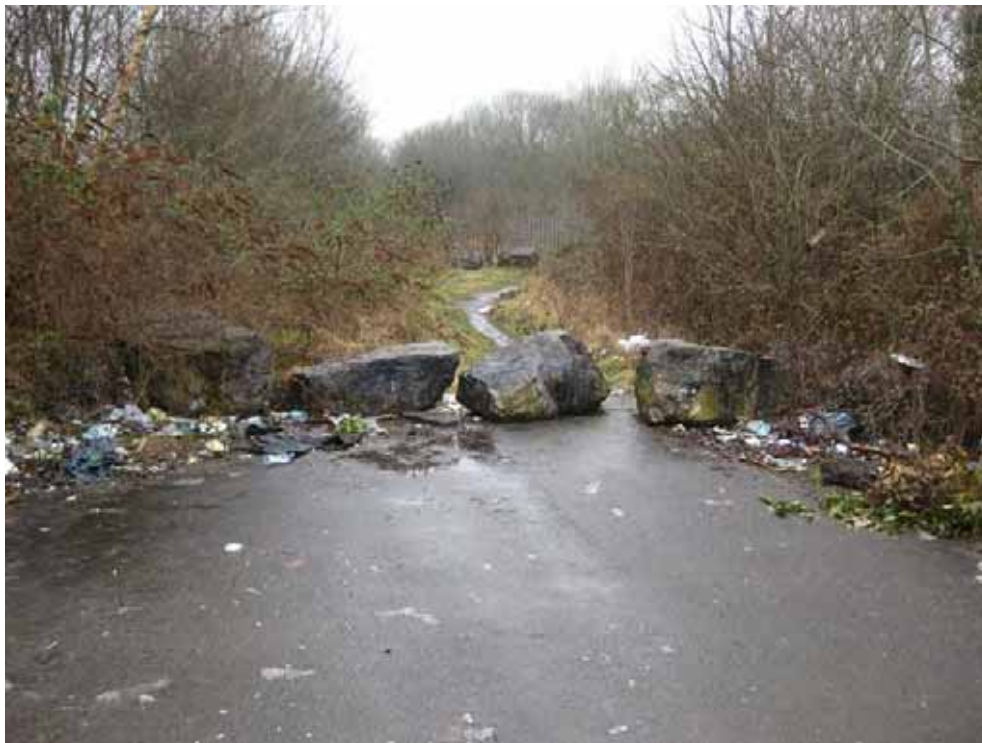
Plate 4 - Facing northwest, boulders have been placed across the path in two layers before a metal security fence.

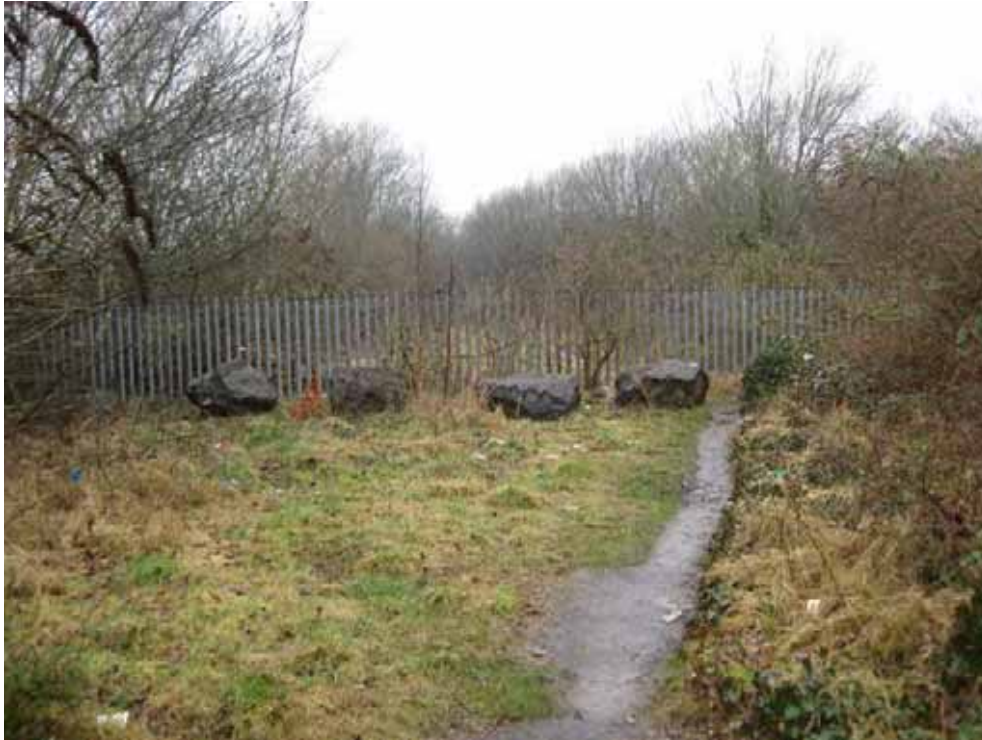
Plate 5 – Facing northwest, second layer of placed boulders and security fence preventing vehicle access.

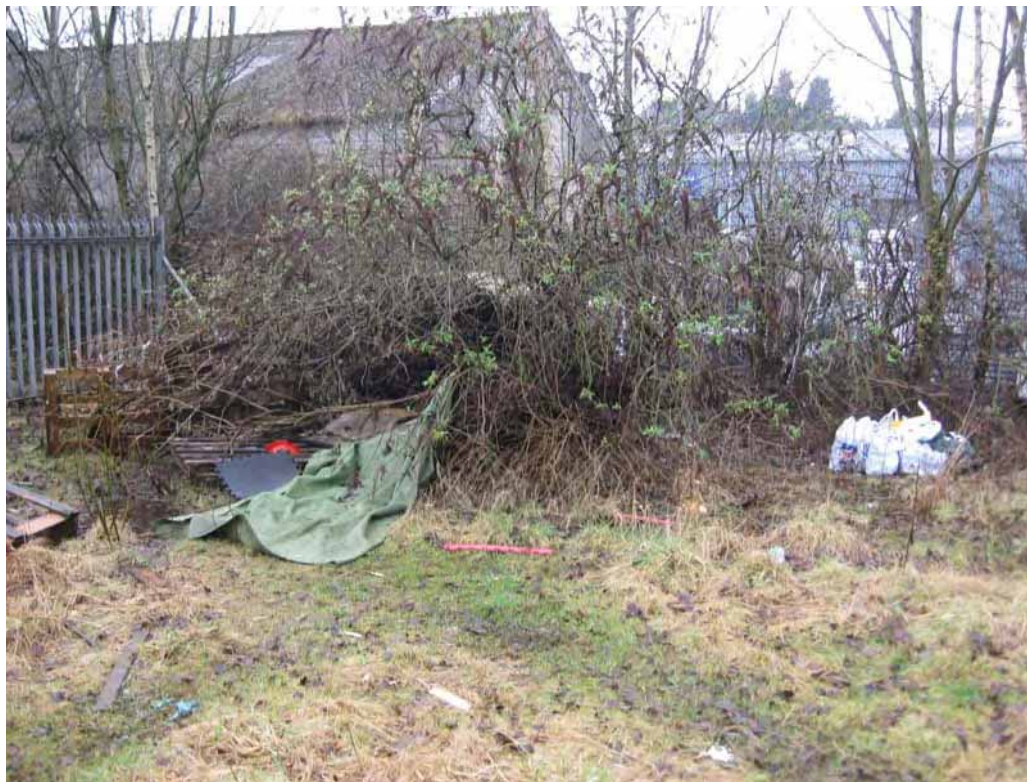
Plate 6 - Facing southwest, evidence of fly tipping of general household waste.

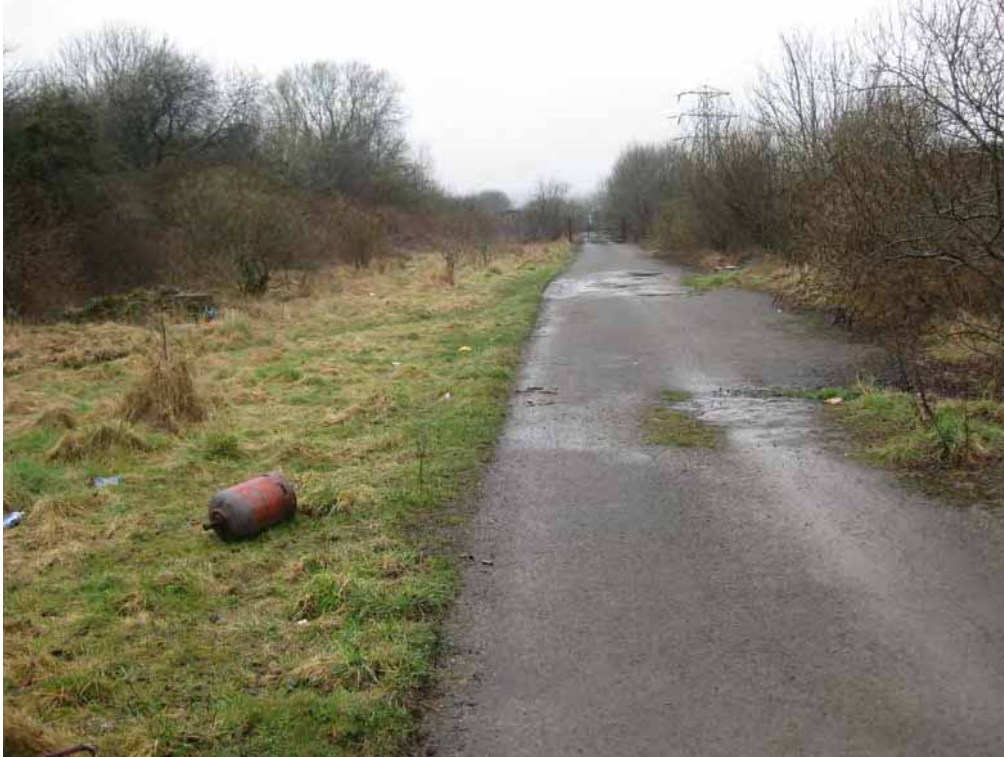
Plate 7 – Facing northwest along the eastern boundary of the site towards electricity sub-station, including further evidence of fly tipping.

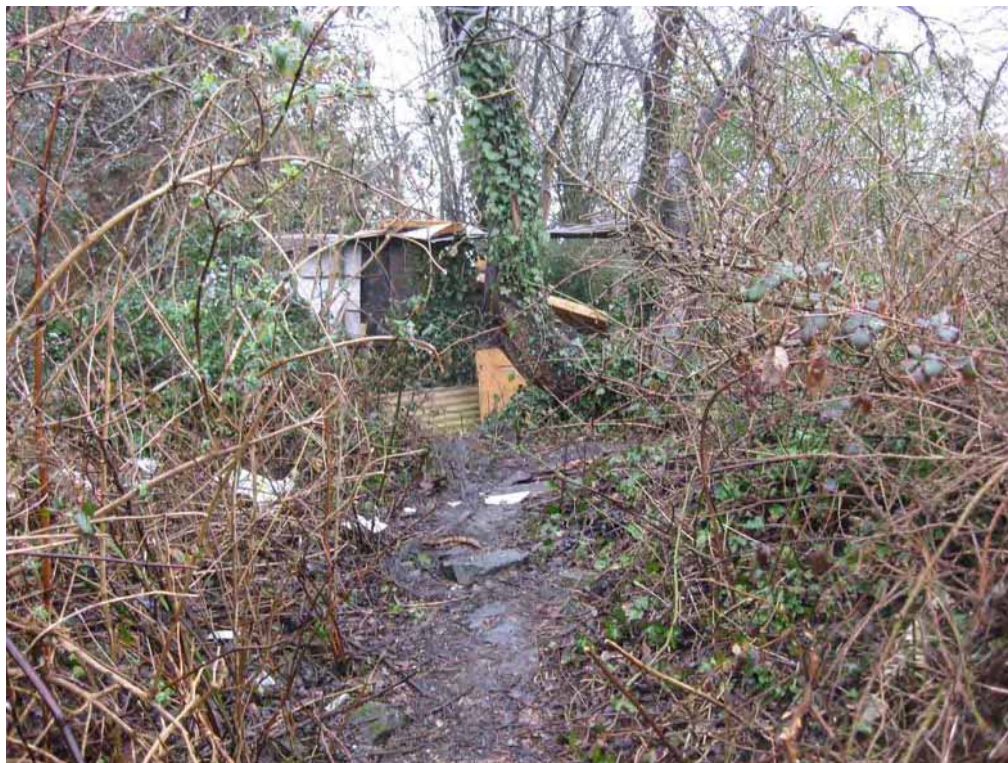
Plate 8 – Facing west, evidence of a shack built in the undergrowth.

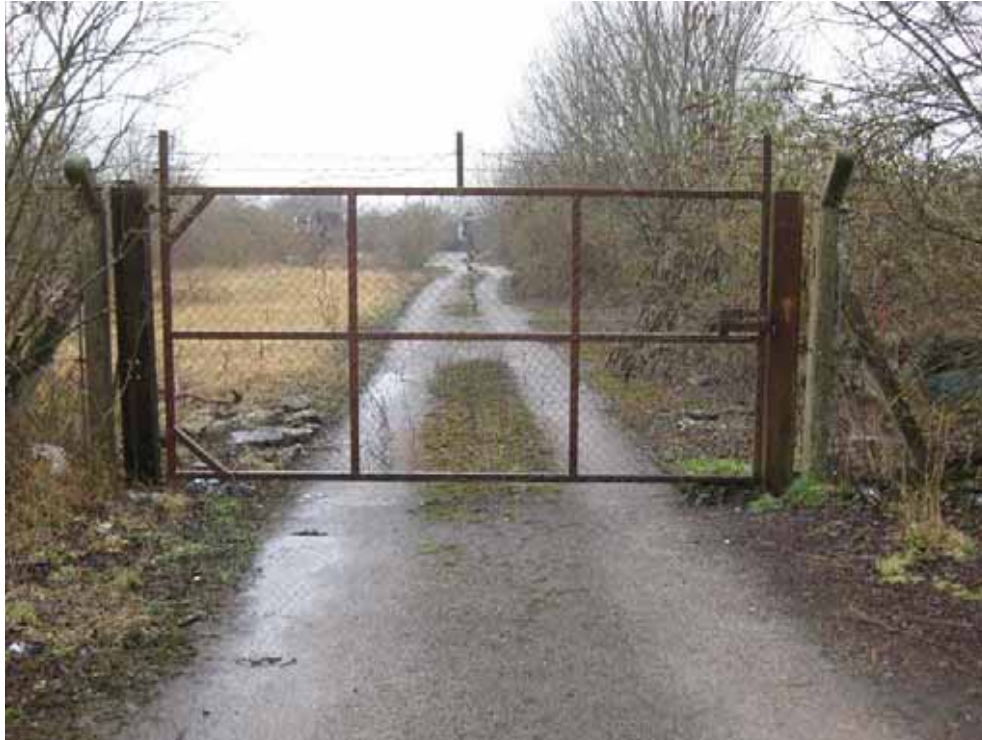
Plate 9 – Facing northwest, another gate and fence crosses the road preventing any further access to vehicles and pedestrians towards the electricity sub-station.

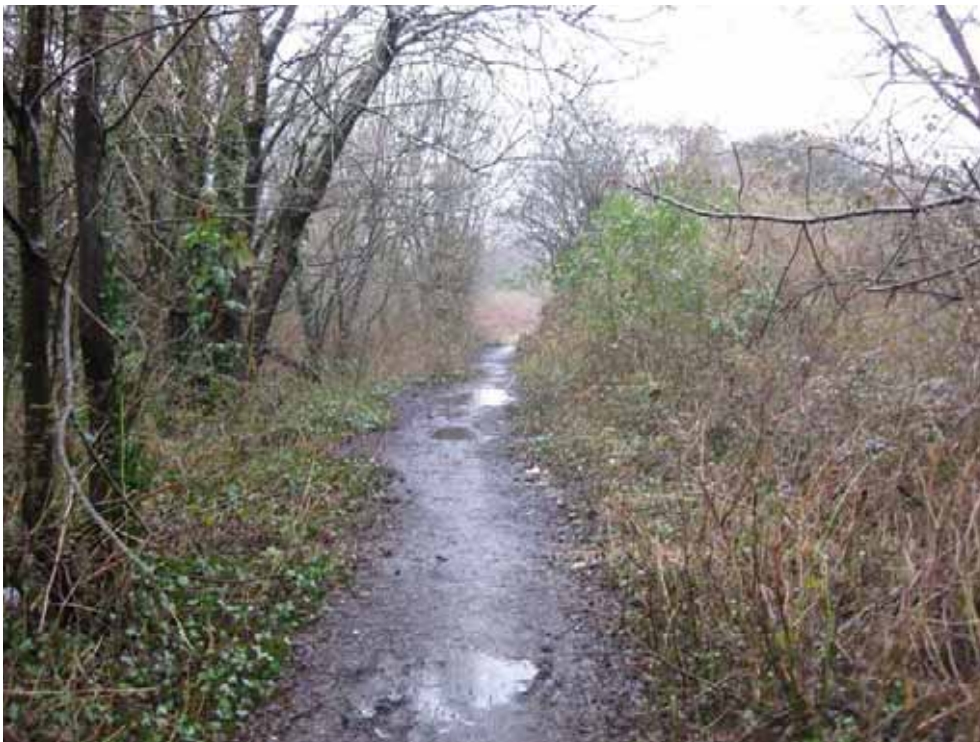
Plate 10 – Facing northwest, pedestrian footpath through overgrown vegetation either side.

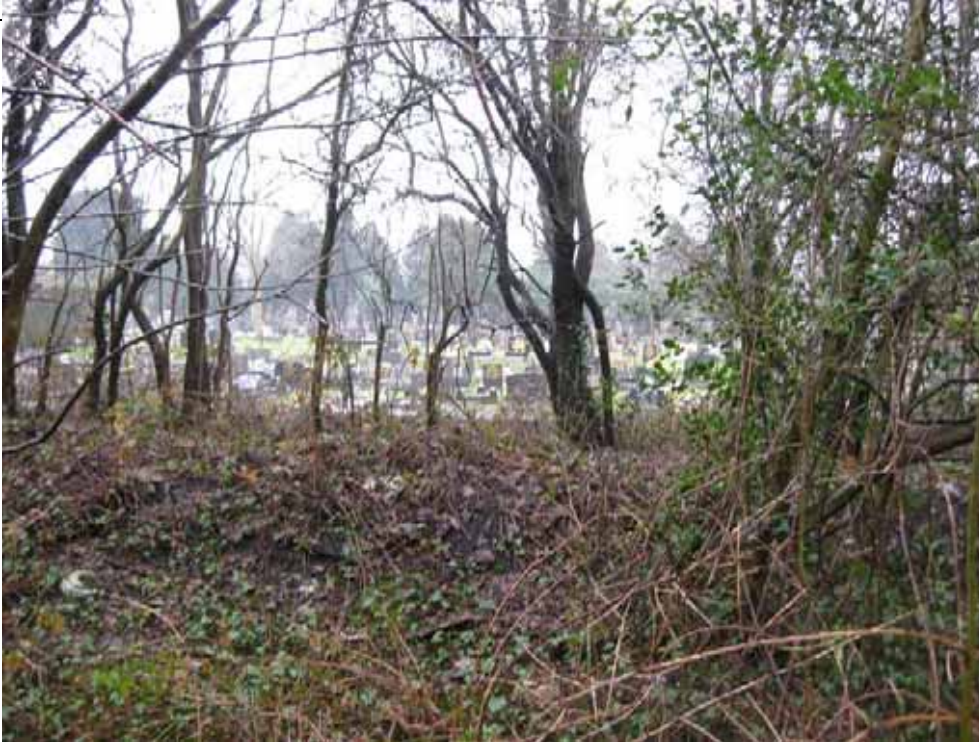
Plate 11 – Facing west, cemetery is visible through the undergrowth to the west of the path.

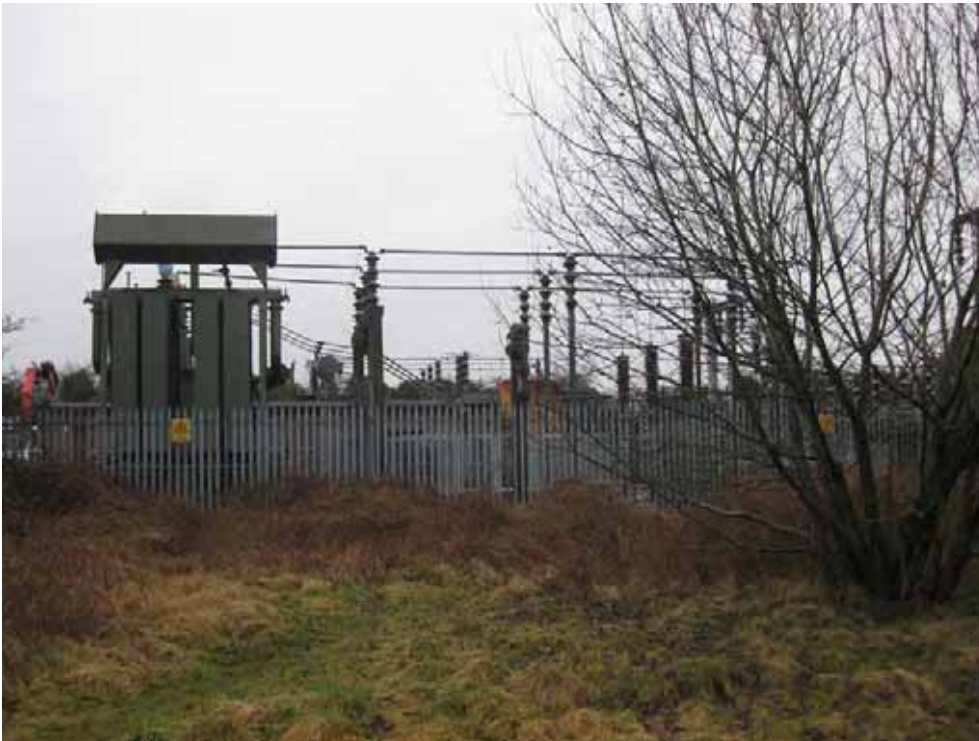
Plate 12 – Facing east, the electricity sub-station comes into view to the eastern side of the path after traveling north 140m.

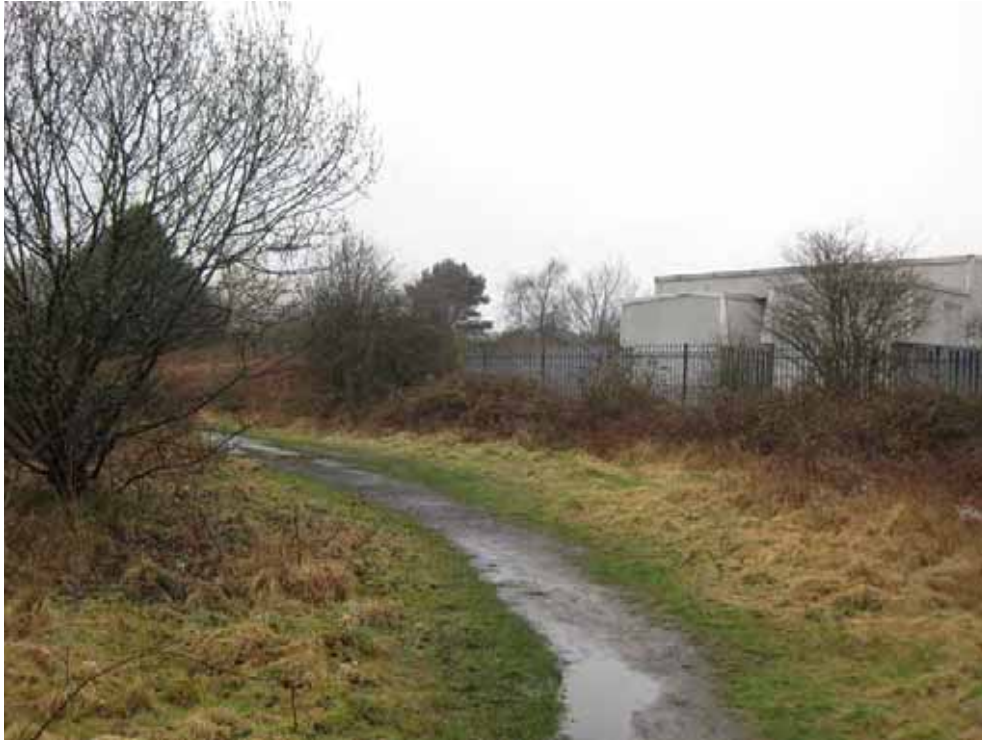
Plate 13 – Facing northeast, the path bends around to the east, towards the sub-station.

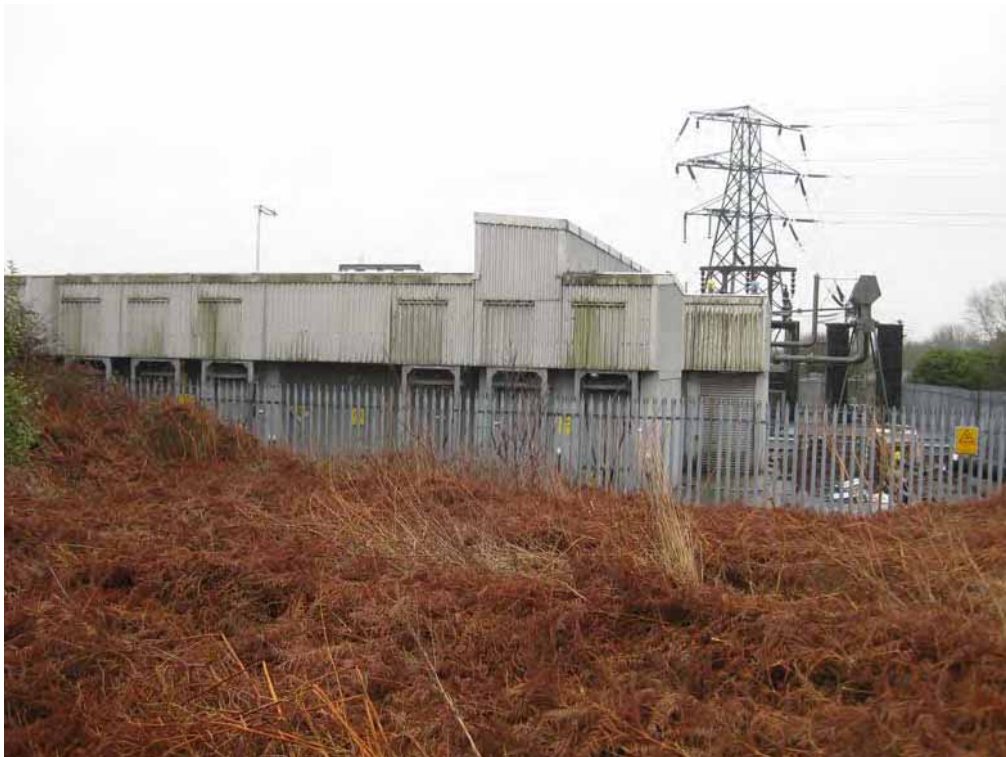
Plate 14 – Facing south, back of the sub-station.

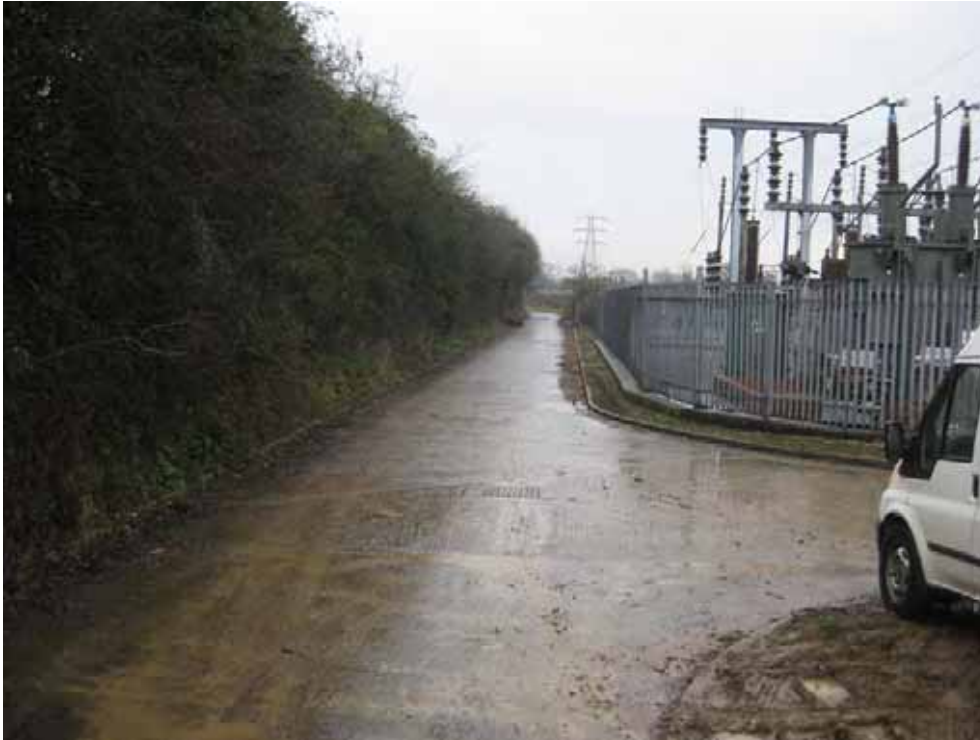
Plate 15 – Facing southeast, a road allowing vehicle access to the east of the sub station.

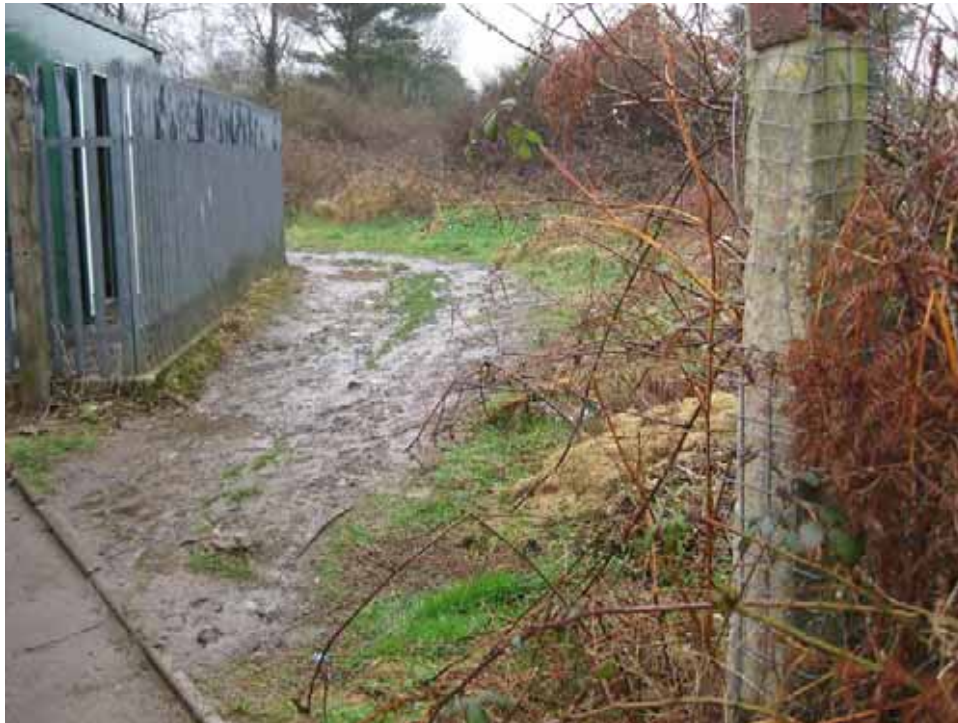
Plate 16 – Facing north, vehicle access onto the site along side of sub-station.

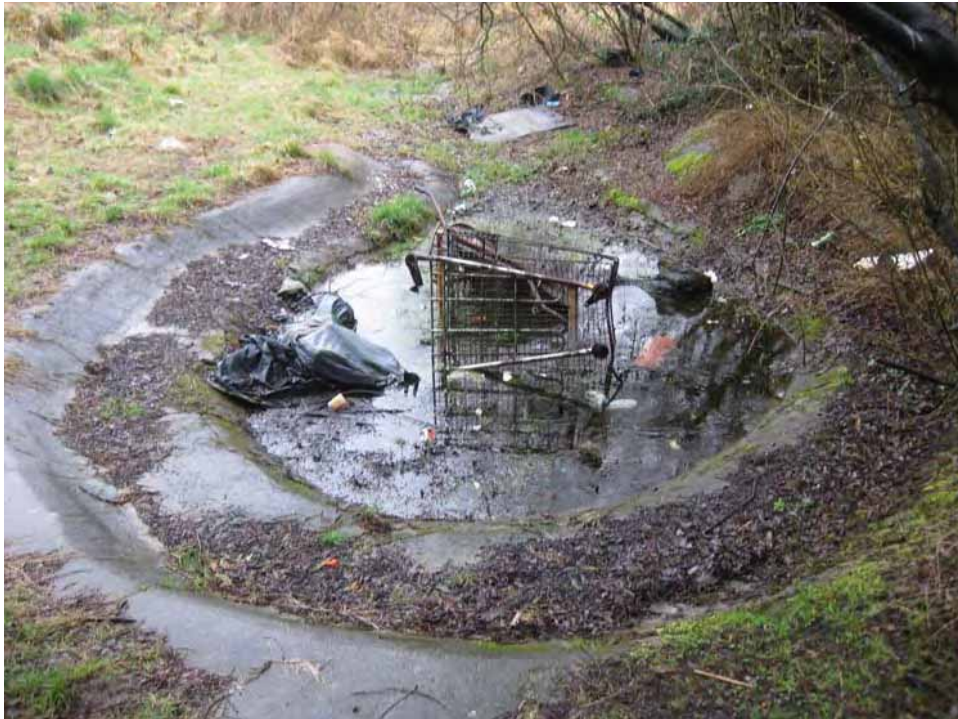
Plate 17 – Facing southeast, abandoned pond with associated rusty shopping-trolley.

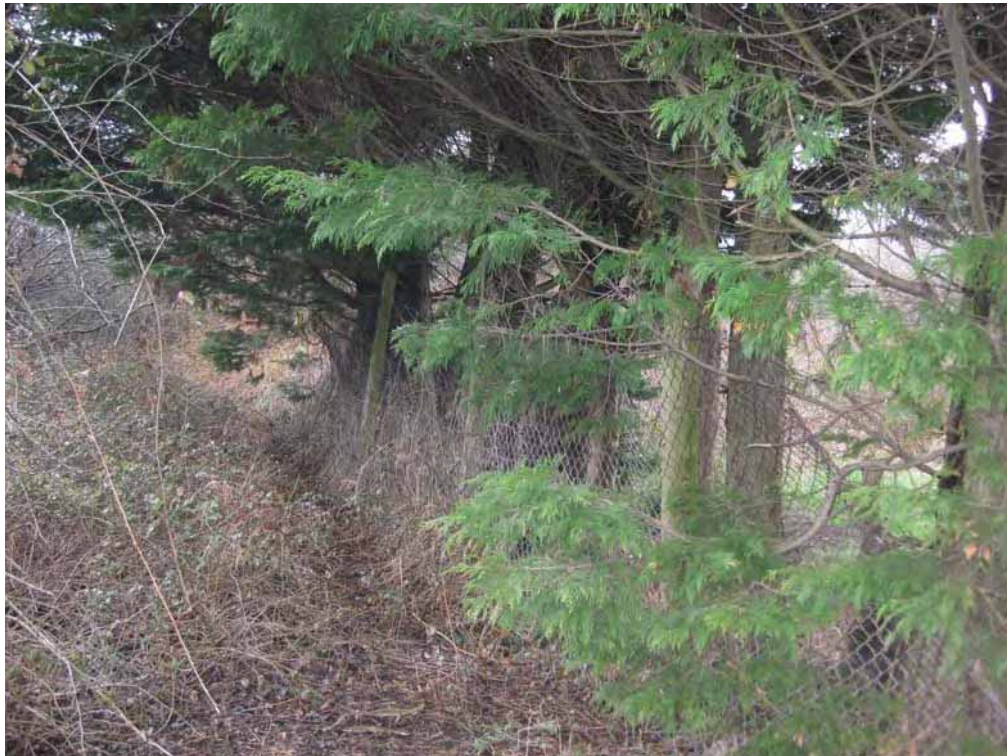
Plate 18 – Facing west, fence with planted conifers adjacent to the pond.

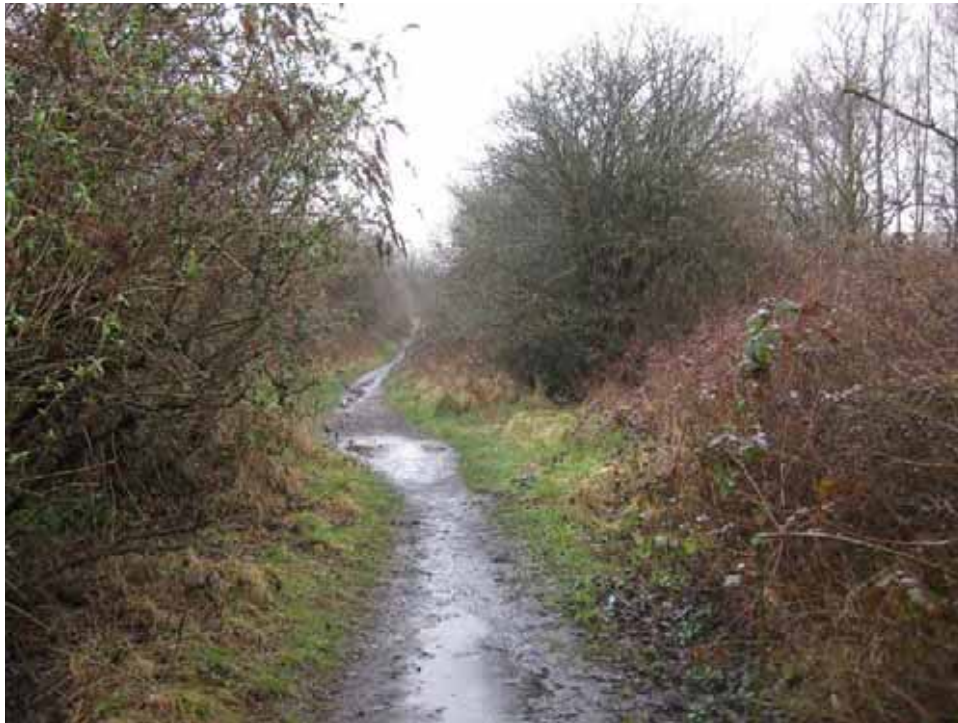
Plate 19 – Facing north, vegetation either side of the path inaccessible to people

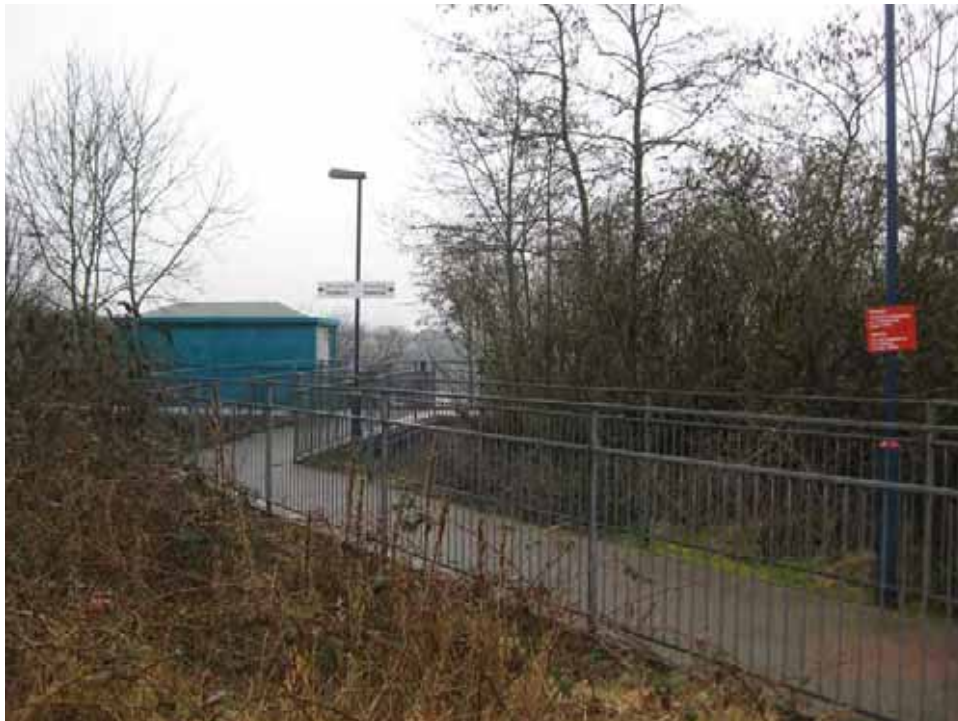
Plate 20 – Facing west, Windmill railway station

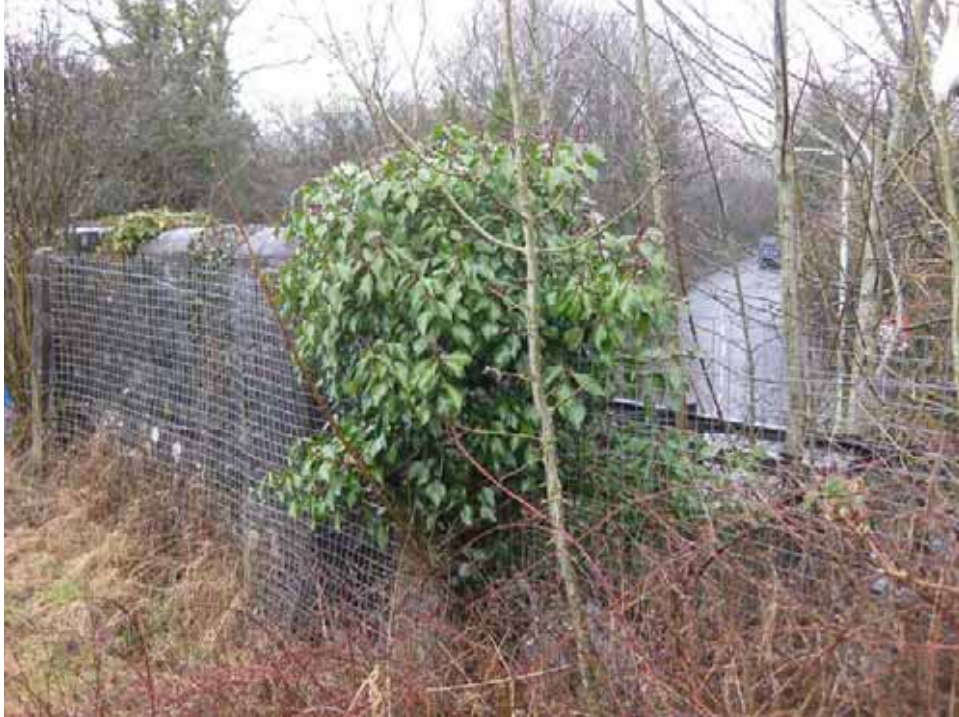
Plate 21 – Facing northeast, the site crosses over Wind Mill Lane.

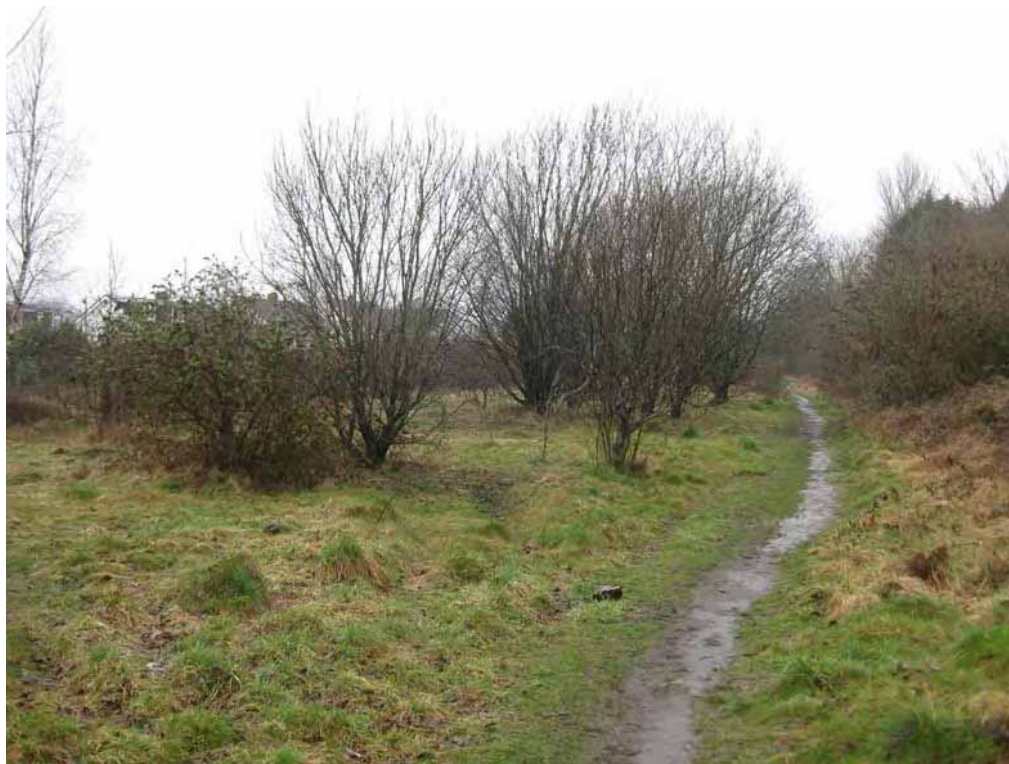
Plate 22 – Facing northwest, less vegetated on the western/railway boundary.

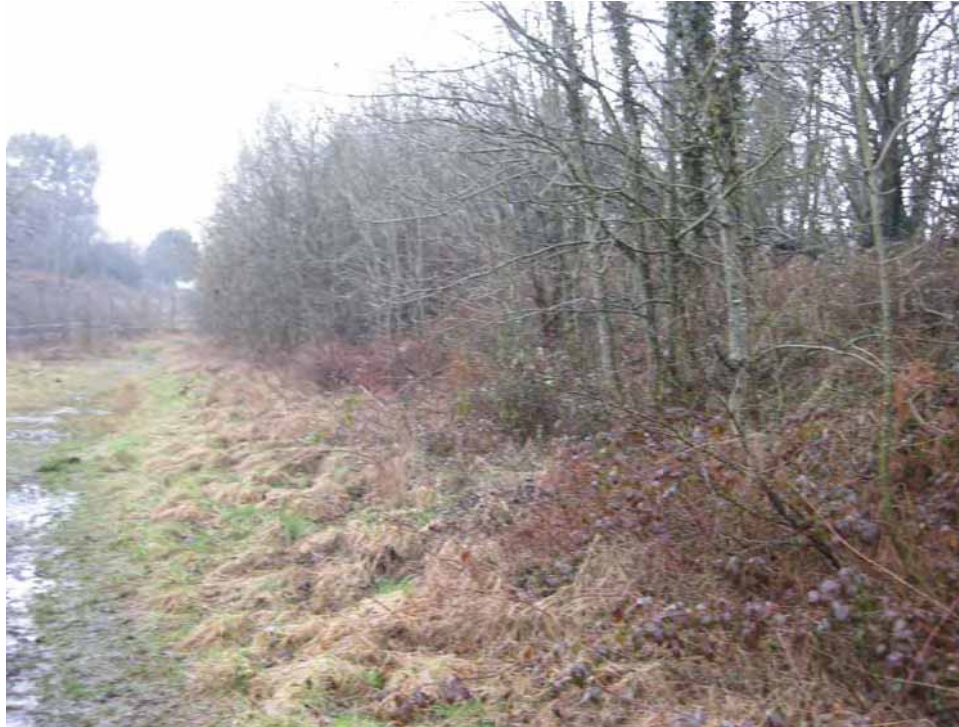
Plate 23 – Facing north, increased vegetation and an embankment along the eastern boundary.

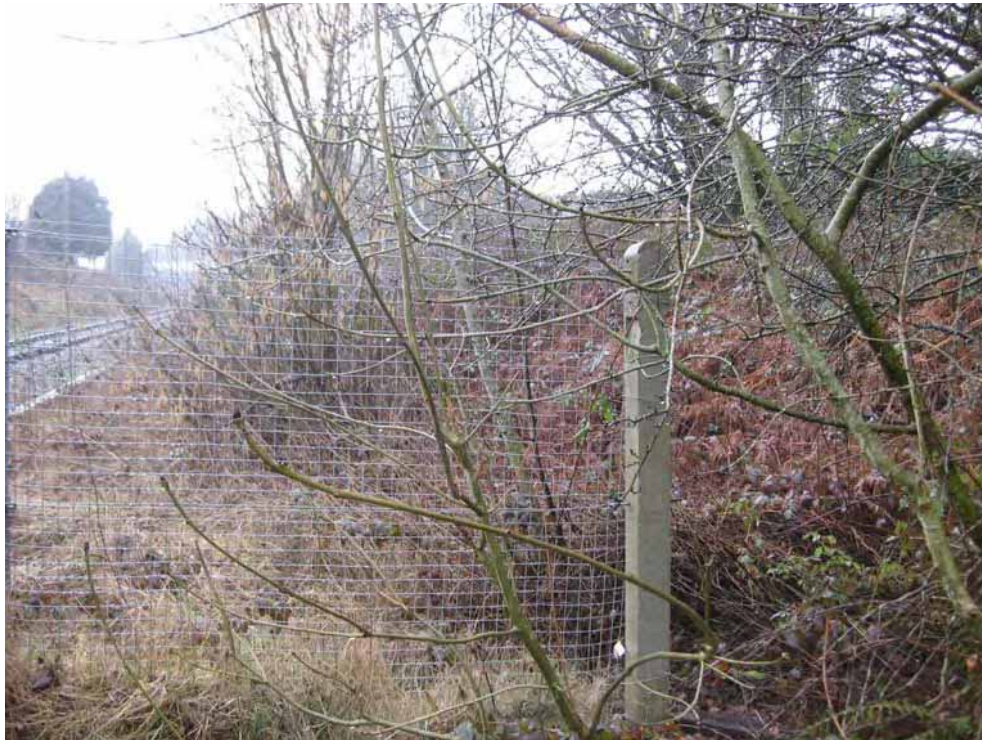
Plate 24 – Facing north, end of the site is signaled by a railway fence across the path.
